McGetrick, P., & Hester, D. (2016). Implementation of a drive-by monitoring system for transport infrastructure utilising GNSS. In *Proceedings of the Civil Engineering Research in Ireland 2016 (CERI2016) conference* [161]

# Implementation of a drive-by monitoring system for transport infrastructure utilising GNSS

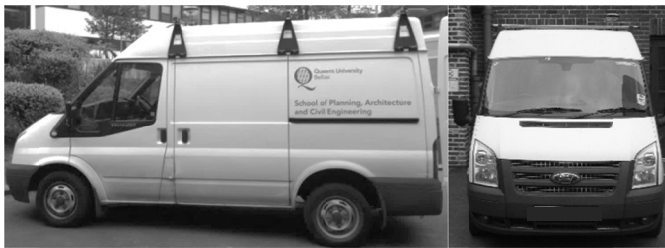
For this field investigation, the instrumented vehicle was a Ford Transit van (Figure 1), weighing 1600 kg and fitted with accelerometers to measure vibration and GNSS receivers to record the vehicle position in the road network. A digital camera was also used to record video footage of each vehicle test run while the average vehicle speed during testing was 30 mph (48 km/h). The details of instrumentation and setup are outlined in the following sections.

Figure 1. Instrumented Vehicle.

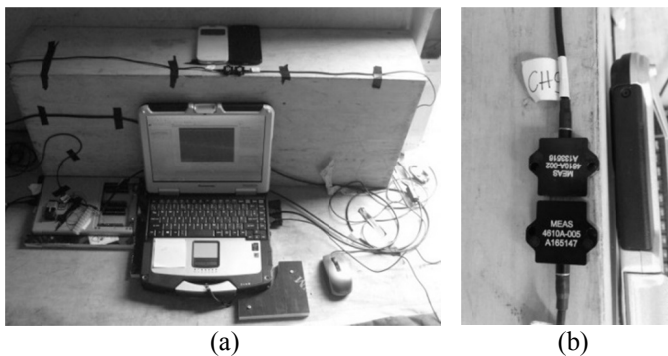
The overall setup of accelerometers in the vehicle is illustrated in Figure 2, consisting of 4 accelerometers measuring vertical vibration.

Figure 2. (a) Accelerometer instrumentation setup (b) uniaxial accelerometers.

Two wired uniaxial accelerometers were installed at the same location in the body of the vehicle, adhesively mounted over the left rear wheel. The installed accelerometers were ultra-low noise signal conditioned model 4610A-002 ( $\pm 2g$ ) and

4610A-005 ( $\pm 5g$ ) units by Measurement Specialties<sup>TM</sup>, shown in Figure 2(b), which provide low-pass filtered output. Excitation voltage was provided by a 9V battery during testing. Both  $\pm 2g$  and  $\pm 5g$  rated accelerometers were tested, for comparison with smartphone sensors and to ensure any large magnitude accelerations greater than 2g were recorded, respectively. The sampling frequency was 1000 Hz, which allows identification of any features with frequency components higher than 100 Hz, which would be undetected by the smartphone sensors.

The built in accelerometers of an LG Nexus 5 and a Samsung Galaxy S4 were used for vertical smartphone acceleration measurements; both devices were mounted over the left rear wheel with adhesive (Figure 2(a)). The LG Nexus 5, retailing at €290 approximately, contains a 6-axis MPU-6515 chip with integrated triaxial MEMS Gyroscope and triaxial MEMS accelerometer by InvenSense Inc., built into the device motherboard. The maximum measurement range during testing was  $\pm 19.61 \text{ m/s}^2$ , equivalent to  $\pm 2g$ , although this can be increased. As vehicle body and bridge vibration magnitudes are generally less than 2g, this range is suitable for bridge monitoring applications. The smartphone sampling frequency was set at a maximum of 200 Hz, which is also adequate for drive-by monitoring.

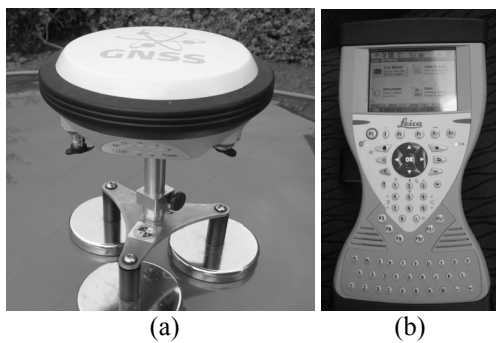
To serve as a reference for the vehicle position recorded by the Nexus 5 during testing, a Leica Geosystems Viva GS14 GNSS smart rover antenna was used to manually log the vehicle location coordinates to a removable SD card throughout testing, incorporating Network Real-Time Kinematic (RTK) corrections [13] obtained via mobile network. The antenna was mounted magnetically on the roof of the van and operated using a Leica Geosystems CS15 controller (see Figure 3). This system can achieve horizontal and vertical accuracies of 8 mm and 15 mm respectively for static measurements, although this is dependent upon various factors such as the number of satellites tracked, constellation geometry and observation time. Accuracy was expected to vary during testing, particularly in urban or wooded areas where satellite visibility or signal strength can be restricted, and due to the movement of the vehicle.

Figure 3. (a) Leica GS14 smart antenna (b) Leica CS15 controller.

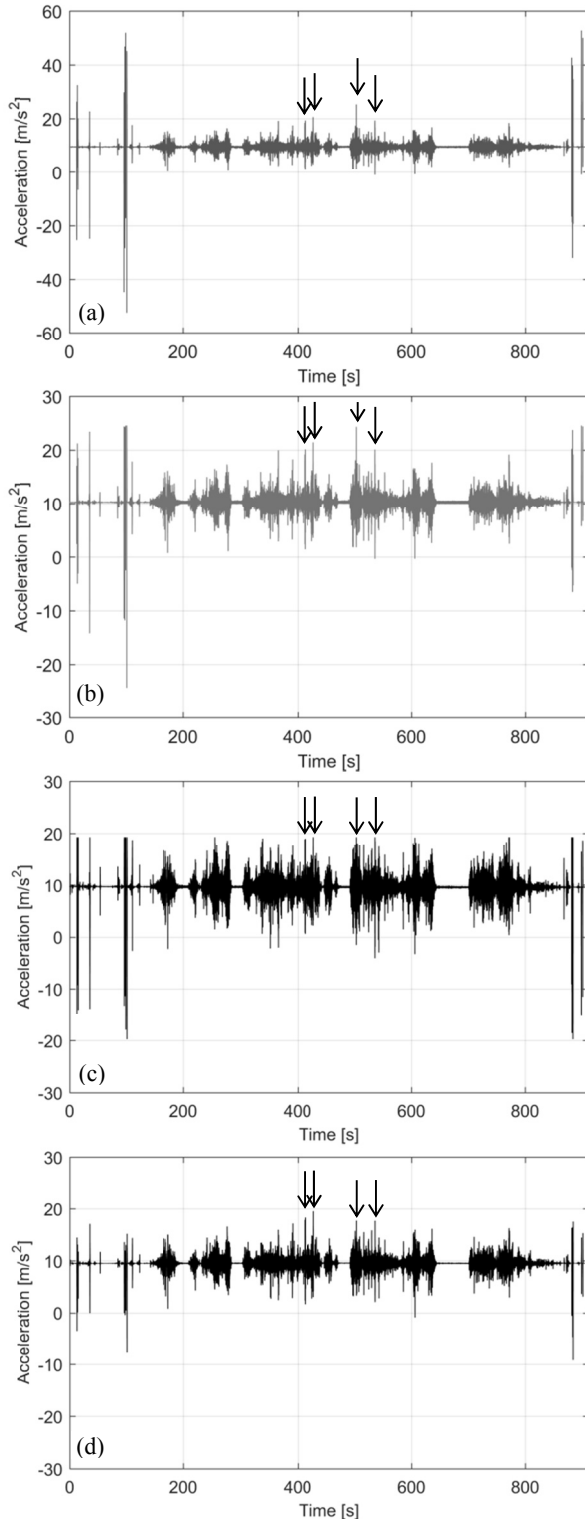
Figure 4 shows the full time history of acceleration measurements obtained from all accelerometers in the instrumented vehicle for route 1, while Figure 5 shows the corresponding spectra. It can be seen that despite the difference in sampling frequency, the smartphone acceleration time histories compare relatively well to the corresponding measurements from the wired 2g accelerometer, however, the Samsung S4 sensor (Figure 4(d)) is not as sensitive to the vibration magnitude as the Nexus 5, in many cases registering less than half the peak acceleration magnitude, which is influenced by its 100 Hz sampling frequency limitation. This is also reflected in the spectra (Figure 5). Although all sensors identify the dominant body bounce vibration mode of the vehicle at 2.3 Hz, the smartphone peak magnitude is 5 times less than that recorded by the wired sensor, indicating lower sensitivity; however, this magnitude difference is reflected across the whole spectrum.

Figure 4. Acceleration measurements for test route 1 (a) 5g uniaxial (b) 2g uniaxial (c) Nexus 5 MPU-6515 (d) S4 K330.

Figure 4(a) shows the wired 5g accelerometer measurements for comparative purposes of positive accelerations; the sharp peaks at the beginning and end of the signals were used to confirm accurate synchronisation while the vehicle was motionless. During movement i.e. from 140 – 860 seconds, only four peaks exceeded +2g, marked in Figure 4 with arrows. However, the maximum peak magnitudes measured by the wired accelerometers were not obtained by the smartphones due to their range limit. The magnitudes and times for these four peak locations are given in Tables 1 and 2 respectively. From Table 1, it can be seen that in terms of smartphone measurements, the Nexus 5 accelerometer is more sensitive overall, reaching its range limit of  $19.24 \text{ m/s}^2$  consistently for peaks exceeding 2g, suggesting that it may be a more suitable device for drive-by monitoring purposes. Also, this accelerometer has the potential to have its dynamic range increased by the user. It should be noted however that this range limit is slightly less than specified ( $\pm 19.61 \text{ m/s}^2$ ), indicating that sensor calibration may be necessary.

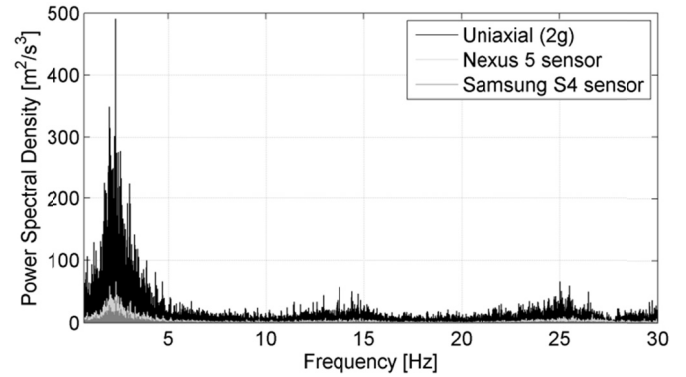
Figure 5. Acceleration spectra for test route 1.

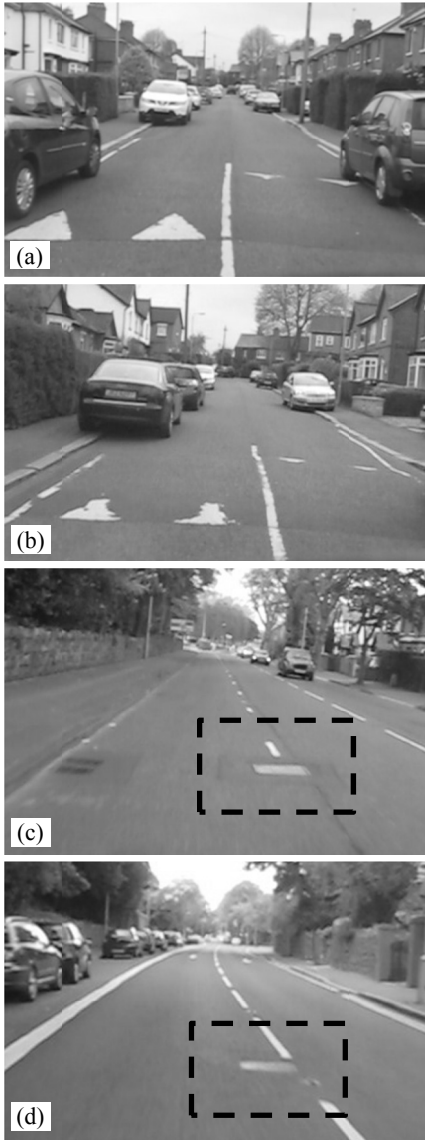
From Table 2, the times corresponding to peaks in the acceleration signals with (left to right numbering) can be used to inspect video footage and timestamped vehicle location coordinates. Figure 6 shows video screenshots corresponding to each peak, highlighting that unique features are present at these locations. Peaks 1 and 2 were caused by speed ramps, while Peaks 3 and 4 were caused by manhole covers.

Figure 6. Video screenshots of peak locations for test route 1 (a) Peak 1 (b) Peak 2 (c) Peak 3 (d) Peak 4.

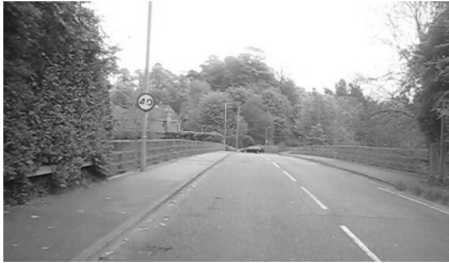
Figure 7. West entrance to bridge crossing over M1 motorway on Dunmurry Lane on test route 2.

An example of the acceleration responses of the wired 2g uniaxial accelerometer and the Nexus 5 accelerometer for test route 2 are shown in Figure 8 for a west-east crossing of the skew-bridge (Figure 7) over the M1 motorway on Dunmurry Lane, which has a total length of approximately 38 m. This response was extracted based on the recorded position of the vehicle (Section 3.2) and inspection of video footage for test route 2. Similar responses were observed for repeated crossings. Firstly, it can be observed that the Nexus 5 accelerometer displays a noisier response, which is expected; the uniaxial accelerometer has been designed and constructed

memory, rather than manually as in this test. Overall, similar issues affecting accuracy were experienced as for route 1. In particular, at the M1 motorway bridge crossing (see Figure 10 inset), overhanging trees restricted recording of location at the western entrance to the bridge (Figure 7). In addition to raw data logging, this problem can be alleviated for GNSS systems by carrying out testing in winter rather than summer, when trees have shed their foliage. Other possible solutions include inertial navigation systems (INS), which incorporate accelerometers, gyroscopes, magnetometers and GNSS receivers, but an equivalent system for accurate vehicle tracking can be relatively expensive.

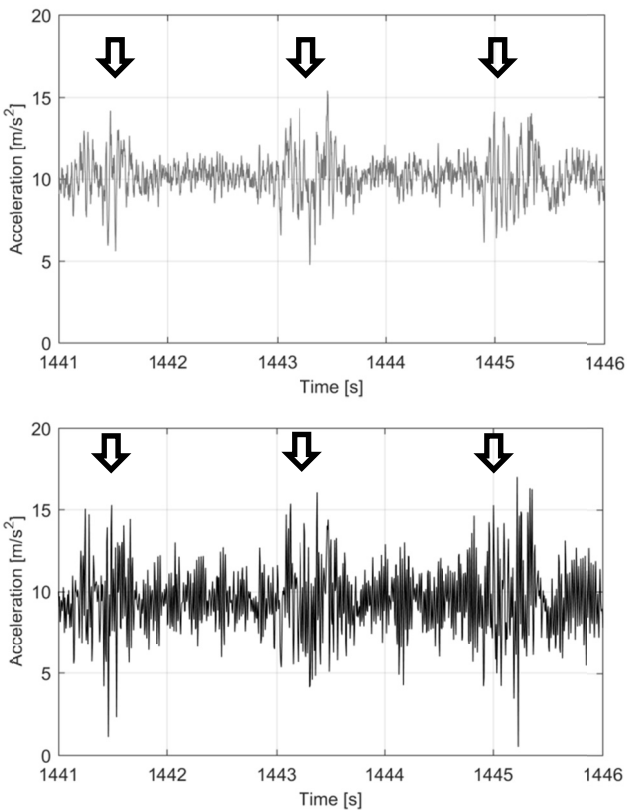
for applications requiring low levels of output signal noise thus some higher frequency components have been removed from its response. However, both accelerometers display three periodic low frequency disturbances.

Figure 8. Acceleration measurements on bridge crossing over M1 motorway (a) 2g uniaxial (b) Nexus 5 MPU-6515.

On inspection of video footage, it can be confirmed that these correspond to the three expansion joints on the bridge, indicating that the drive-by monitoring system, at a minimum,

has potential to monitor deterioration of the expansion joint covering and/or the joint itself through analysis of the vehicle's dynamic response. Further analysis of these responses is necessary to investigate the effectiveness of other indirect drive-by monitoring methods and algorithms, including those developed by the authors.

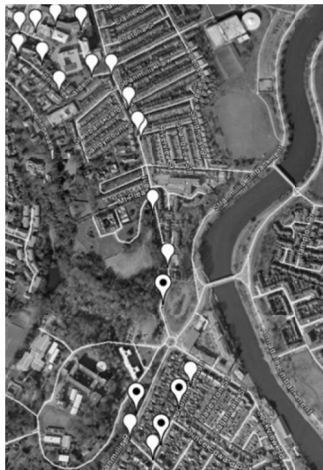
Figure 9 shows the vehicle location coordinates logged and timestamped during test route 1 by the Leica GS14 smart antenna. The four peaks identified from the acceleration time histories are indicated by white icons having a black dot, highlighting that where video or imagery are unavailable in practice, the location of specific points of interest can be identified via GNSS. These coordinates were logged manually as static points, thus accuracy varied due to the movement of the vehicle. The coordinate quality ranged from 0.01 m in relatively open areas to 8 m in wooded areas. The largest causes of error were trees or wooded areas lining the road which restricted a clear view of the sky for the antenna.

Figure 9. Vehicle position coordinates logged using Leica GS14 for test route 1.

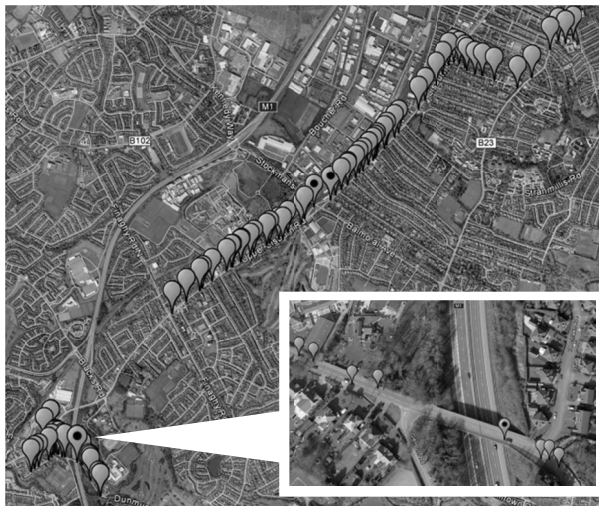
The vehicle position coordinates logged by the Leica GS14 during test route 2 are shown in Figure 10, where icons with black dots indicate two separate bridge crossings. The coordinate quality ranged 0.01 m to 5.7 m, averaging at 0.4 m. A gap in recorded coordinates can be seen at the bottom left of Figure 10; this was caused by a temporary crash of the CS15 controller operating system. This can be overcome by automatically logging raw data to the GS14's internal

Figure 10. Vehicle position coordinates logged using Leica GS14 for test route 2.

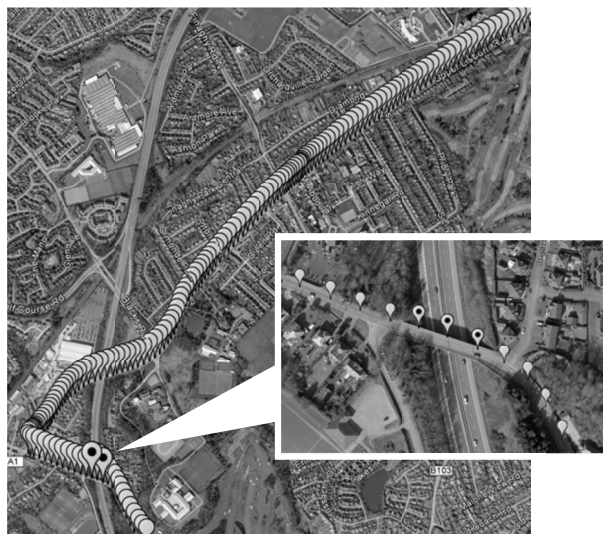
Figure 11 illustrates the vehicle position recorded by GPSEssentials during test route 2. The rapid update of position and accuracy in the region of the M1 bridge crossing is particularly of note – for this application its performance has at least equalled and possibly surpassed the Leica system. Therefore, there is a trade-off between optimum location for each application, unless an external antenna is used for the

Figure 11. Vehicle position coordinates logged using GPSEssentials smartphone application for test route 2.

smartphone. Despite this, overall it was observed that the smartphone accuracy was sufficient to identify when the vehicle was on the bridge. In terms of post-processing and visualising coordinates, GPSEssentials was very straightforward due to the output of a .kml format file; the Leica system required more user post-processing time to achieve the same output.
